# Safety Alert

## Leighton Buzzard near miss

Ref: NRX20-05

Location: Leighton Buzzard, West Coast Mainline South, NW&C

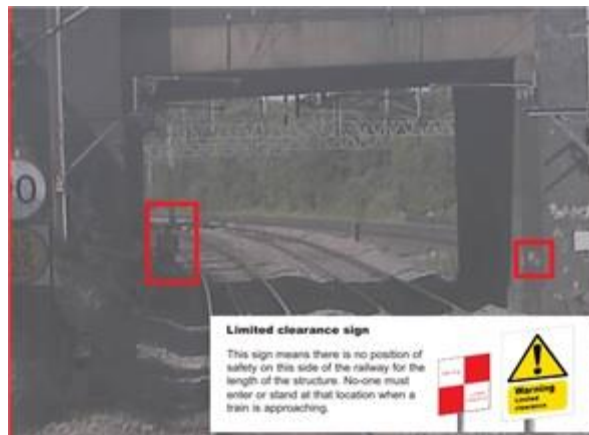
One of the track workers walked through a limited clearance overbridge.

A passenger train travelling at line speed passed the track worker as he walked through the bridge. The worker pressed against the bridge abutment but could not have achieved the require 2m clearance. The train driver was so shaken by the incident he had to be relieved at the next station stop.
